Property Inspection Report

**123 Main Street
Springfield, MA 01109**

*CLIENT: Doe John
INSPECTOR: Christopher Benney
LICENSE: CT 974 & MA 1025*

*DATE OF INSPECTION: 7/6/2023
TIME OF INSPECTION: 9:00am*

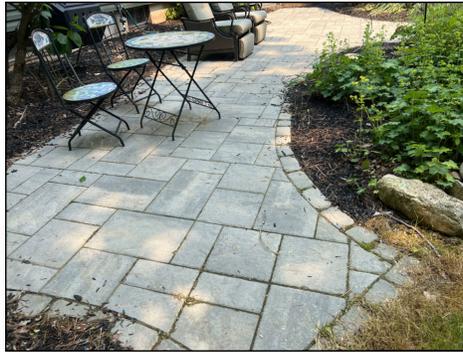
Grading

- **Update/Improvement:** The home had areas of neutral or negative drainage that will route runoff from precipitation toward the foundation. Inadequate clearance may result in moisture intrusion of the structure. Excessively high moisture levels can result in damage to the home structure or materials from decay or deterioration and may result in conditions which encourage the growth of microbes such as mold fungi. Re-grade around the home perimeter to provide increased clearance from grade.

- **Maintenance:** The hatchway is low to the ground which could allow water to enter the foundation. Have a qualified landscaper modify the grading to successfully direct the water away from this area.

- **Maintenance:** Vegetation in close proximity of the exterior walls should be cut back to avoid potential problems from moisture or insects. Prune/trim vegetation back at least 12" from the exterior and have a qualified person evaluate any surfaces that were hidden at the time of the inspection.

- **Maintenance:** Large trees near the house have limbs that overhang the home. Falling limbs due to conditions such as wood decay, high winds or heavy snow loads may cause personal injury or damage. Significant weakening of large limbs by conditions such as core decay may not be visible by persons without special training. Have overhanging trees evaluated by a qualified arborist and limbs that overhang the roof be cut back. Evaluating trees lies beyond the scope of the general Home Inspection.

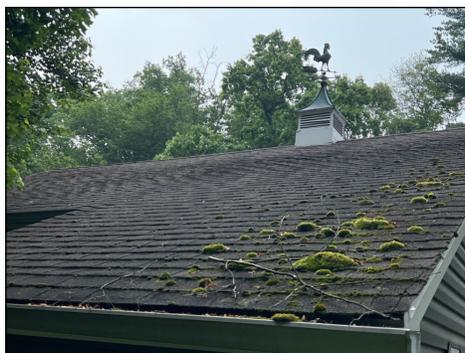
- The roof appears to be nearing the end of its life. The observation of the shingles include: moss and/or lichen, discoloration, advanced granule loss. Remaining service life cannot be predicted. Have a roofing contractor evaluate the roof and provide costs for replacement.

- **Maintenance:** Debris should be removed from the roofing to reduce risk of leaks and early roof wear.

- **Maintenance:** Nail pops were observed at the roof shingles. Nail pops can be caused by a variety of reasons. When the temperature changes, expansion and contraction can cause the nails to pop up and lift the shingles. Nail pops can occur when shingles were not nailed tightly when the roof was installed. Also, the installers could have used nails that were too short. It is not uncommon to have a few nail pops, but left unattended, the roofing system will be compromised, and water could penetrate the wood causing leaks and interior damage. Have a roofing contractor assess and make necessary repairs and monitor for maintenance.

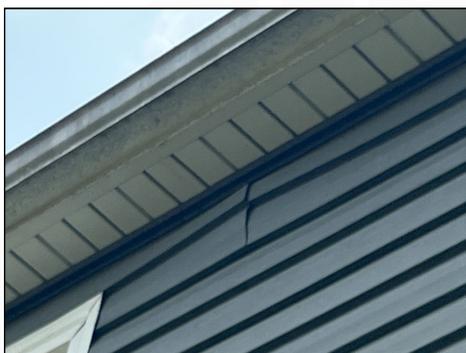
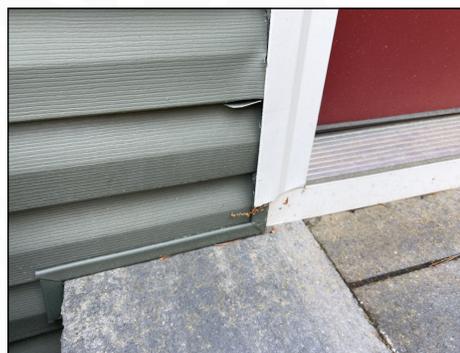
- Maintenance: There is minor damage to the siding and/or trim. This damage can allow water intrusion and should be replaced by a contractor.
- Maintenance: There are opening/penetrations that are not sealed at the exterior. This could allow water to penetrate to sub surfaces. Have a contractor seal all openings for water tightness.
- Maintenance: One or more areas of siding were buckled. This could be caused due to the siding being installed too tightly and cannot expand/contract under the heating and cooling of the material (thermal expansion). Have a siding contractor further evaluate and make necessary repairs.

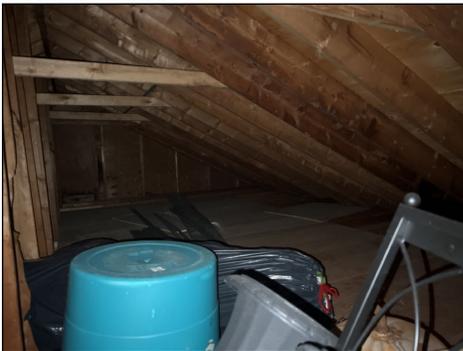
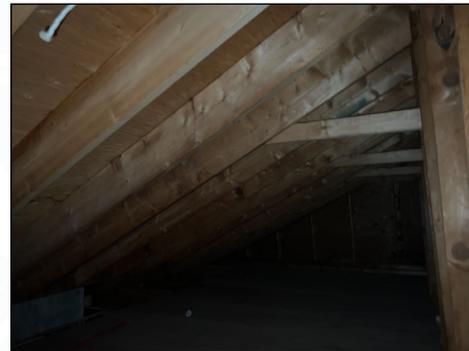
- **Maintenance:** Staining/discoloration was observed at one or more locations in the attic on the roof backing, that appeared to be the result of prior roof leakage. Prior repairs could not be confirmed and it could be possible that leaking still be ongoing. Have area(s) leak-tested by a qualified roofing contractor to determine the chances for future leakage and make repairs as needed.

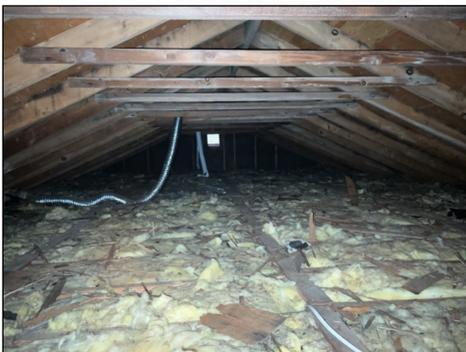
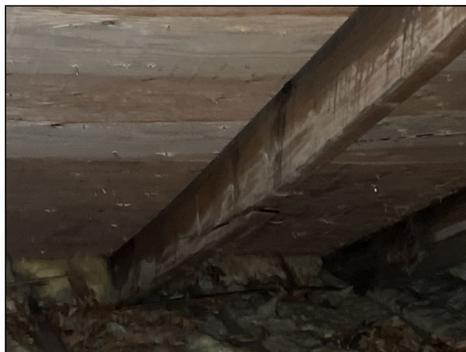
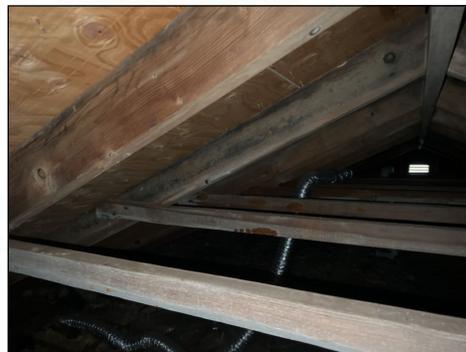
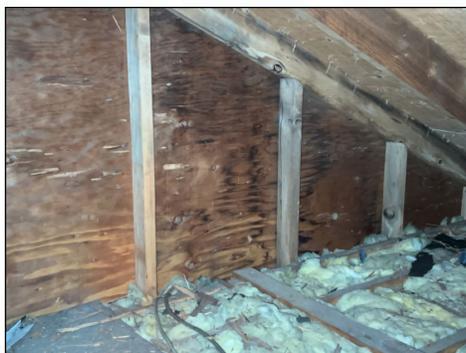
Attic		
Page 19	Roof Framing & Sheathing	<ul style="list-style-type: none"> The attic had area(s) of discoloration that appeared to be microbial growth, possibly mold. Confirming the presence of mold would require laboratory analysis. To avoid potential damage to building materials or the development of unhealthy conditions related to mold, have the source of moisture identified and the condition corrected. All work should be done by a qualified contractor.
Electrical		
Page 36	Conditions	<ul style="list-style-type: none"> Repair/Defect: The electrical service drop does not appear to be water tight at the cable siding penetration. The lack of sealant could allow water to enter, a potential safety issue. Have the cable entry points sealed against water entry. Then monitor and maintain as needed for water tightness.

- The attic had area(s) of discoloration that appeared to be microbial growth, possibly mold. Confirming the presence of mold would require laboratory analysis. To avoid potential damage to building materials or the development of unhealthy conditions related to mold, have the source of moisture identified and the condition corrected. All work should be done by a qualified contractor.

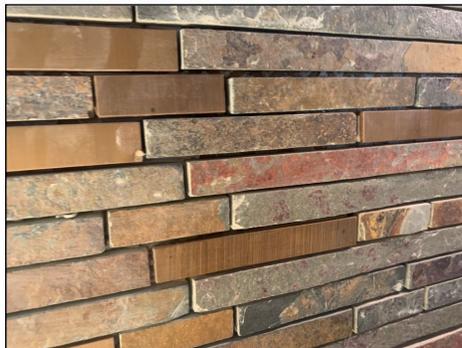
- **Maintenance:** All the back splash tiles had missing grout at seams. Have a contractor make needed repairs for water tightness. Conditions of sub surfaces were not visible and not evaluated.

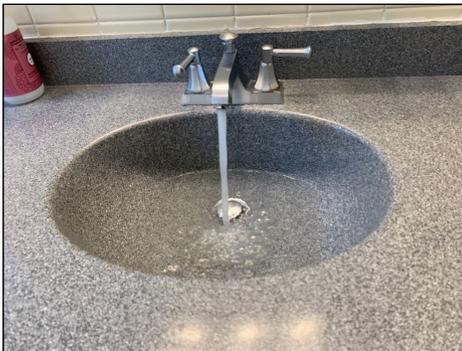
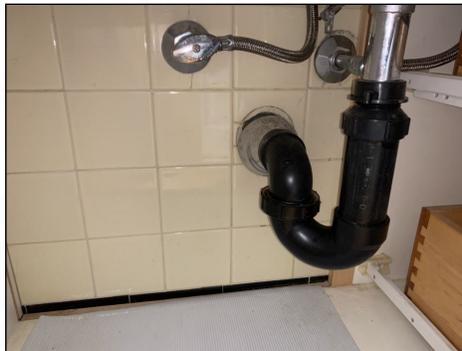
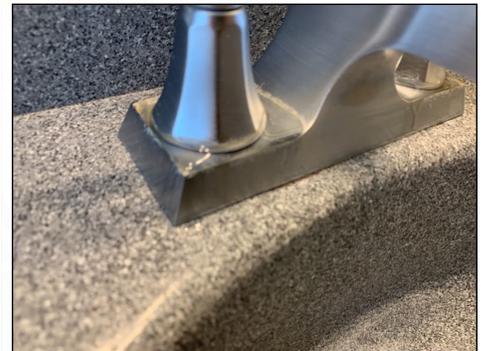
- **Maintenance:** The sink cold water faucet handle leaks during use. Have a plumbing contractor make repairs as needed.

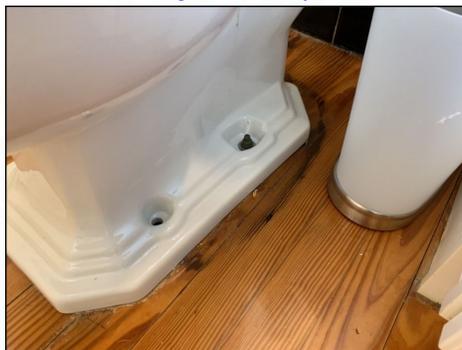
- **Maintenance:** The toilet has stains around the base where it meets the floor. It is undetermined if the toilet was leaking at the time of the inspection. If the toilet has a leak; This condition is typically due to failure of the wax gasket that seals the toilet to the floor. Either monitor or seek further evaluation from a licensed plumber to avoid sub floor damage from decay.

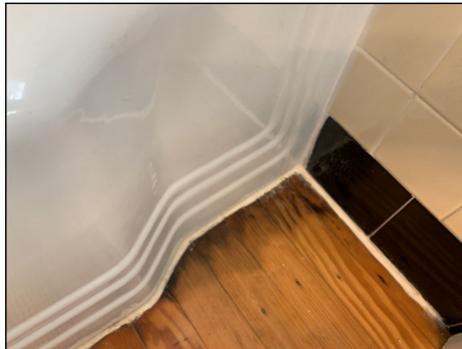
- Maintenance: The wall above or at the side of the shower/tub surround shows some visible deterioration. Hidden surfaces were not evaluated. Have a contractor assess and make repairs.

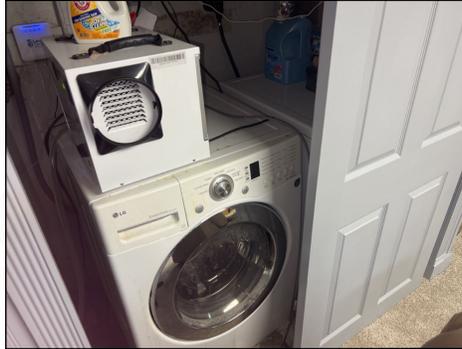
• **Update/Improvement:** There were no Ground Fault Circuit Interrupter (GFCI) electrical receptacle installed in the main laundry area. Modern building standards calls for these type of receptacles in any areas with an increased risk of shock due to electrical risks, such as water. Have the receptacle replaced where needed by a qualified electrical contractor.

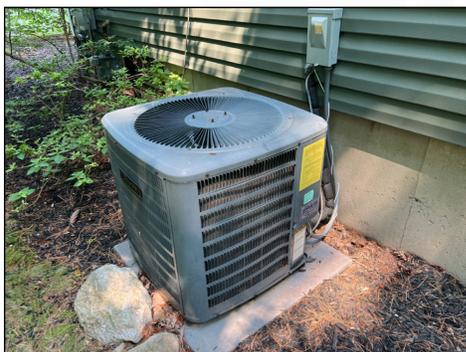
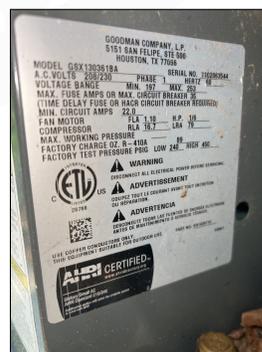
- The condenser unit is towards its end of life due to the following observations: visible wear, visible condition, manufacturer label, known age - The unit was operated during the inspection and was performing as expected. A system at this point in its lifespan will require additional maintenance and might need replacement sooner than later. It cannot be predicted how long the component will preform for before replacement is needed. A HVAC contractor can provide information estimates for cost replacement and should conduct regular maintenance to extend longevity.

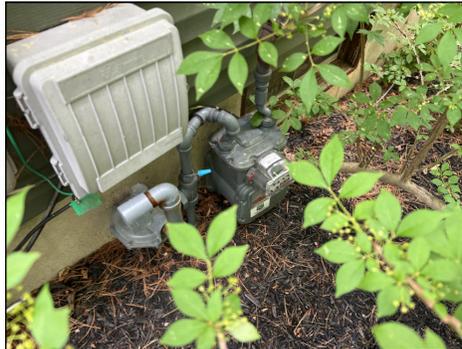
• **Update/Improvement:** There was no visible bond on the gas piping to the buildings electrical system. An electrical bond is an electrically conductive and continuous path from the gas piping to the grounding electrode system. If a bond is not installed and if the gas pipe became electrified, this becomes a safety risk and also could damage the piping. Have a licensed electrical contractor install a bond at the proper location.

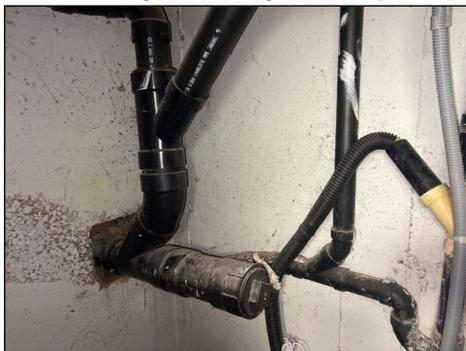
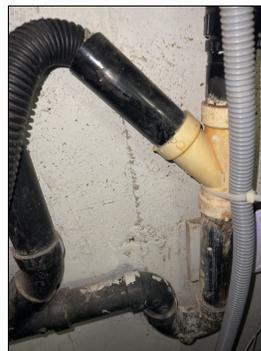
- One or more drain pipes showed signs of past leaks. If leaks are observed in the future have a licensed plumber access and make repairs.
- **Maintenance:** Plastic ABS and plastic PVC waste pipes were connected to each other. Connections between dissimilar plastics require the use of a special "transition" glue. Confirming that the proper glue was used exceeds the scope of the General Home Inspection. The Inspector observed no leaks at fittings connecting dissimilar plastics. Have a licensed plumber evaluate and make corrections if identified.

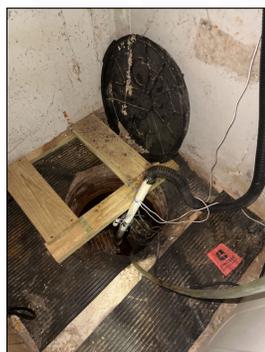
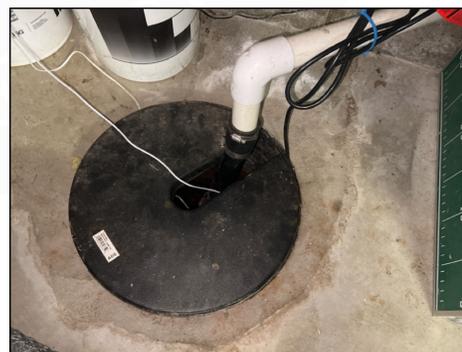
- **Update/Improvement:** The sump pit cover was missing or improper. The sump pit should be covered to prevent water from evaporating into the building, prevents debris from entering the pit and possible personal injury. Have a qualified contractor install a proper cover.
- **Maintenance:** The sump pit is dirty with soil and debris that can impact the performance/functionality of the sump pump. Have a qualified person clean the sump pit ensuring proper operation of the pump.
- **Update/Improvement:** The sump pump drained the sump pits excess water in to the main waste line. Many jurisdictions do not permit pumped water into public sewer systems. Have a qualified contractor reroute the drain pipe to the exterior either to a dry well or least 6 feet away from the foundation.

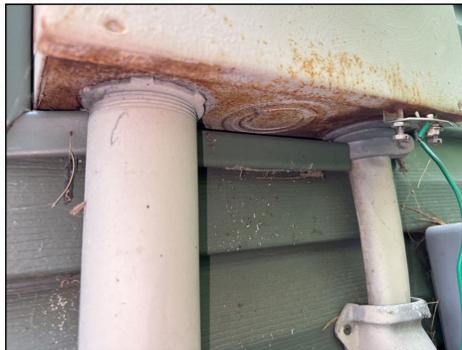
• **Repair/Defect:** The electrical service drop does not appear to be water tight at the cable siding penetration. The lack of sealant could allow water to enter, a potential safety issue. Have the cable entry points sealed against water entry. Then monitor and maintain as needed for water tightness.
