Property Inspection Report

**123 Main Street
Springfield, MA 01109**

*CLIENT: Doe John
INSPECTOR: Christopher Benney
LICENSE: CT 974 & MA 1025*

*DATE OF INSPECTION: 7/6/2023
TIME OF INSPECTION: 9:00am*

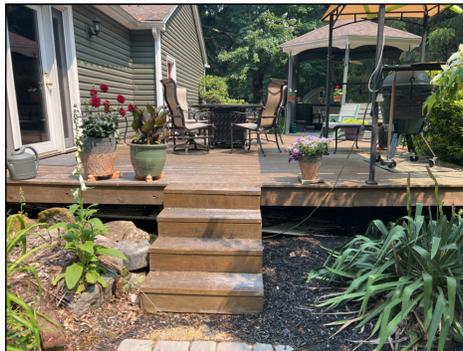
- The deck floor structure was not flat or level. This condition appeared to be the result of poor building practices.
- Update/Improvement: There does not appear to be standoff(s) at the bottom of the posts where they attach to the concrete footing at the deck. Standoffs leave space for the top of the anchor bolt and nut, it also reduces the chance of water wicking up into the end grain of the post that can lead decay, deterioration or premature failure. Consider having standoff installed by a qualified contractor.

- Maintenance: Deck planking (the walking surface) had moderate wear or deterioration visible at the time of the inspection at the deck. Routine maintenance will improve its lifespan.

- Update/Improvement: At the deck staircase, the greatest tread depth exceeded the shallowest tread depth by more than the 3/8 of an inch recommended by generally-accepted current standards. This condition is a potential trip risk. All corrections should be made by a qualified contractor.

- Update/Improvement: The deck staircase had no handrail(s). Consider consulting with a qualified contractor to discuss options and costs for handrail installation for safety.

- Update/Improvement: The deck had walking surfaces greater than 30 inches above grade that were not protected by a guardrail. Safe building practices dictate that any walking surface 30 inches or more above grade should have a guardrail. Have corrections made by a qualified contractor.

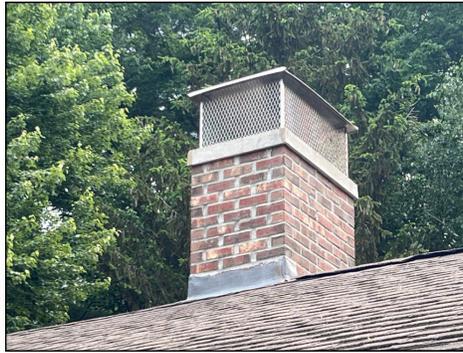
Chimney #1 Location: Left

- The crown and flue of the chimney could not be fully inspected. The inspection of the chimney flue lies beyond the scope of the General Home Inspection. Although the Inspector may make comments on the condition of the portion of the flue readily visible from the roof, a full, accurate evaluation of the flue condition would require the services of a specialist. Have the chimney(s) professionally fully evaluated including a level 2 evaluation.
- At the time of the inspection, the Inspector observed no deficiencies in the condition of the portions of the chimney visible from the ground.

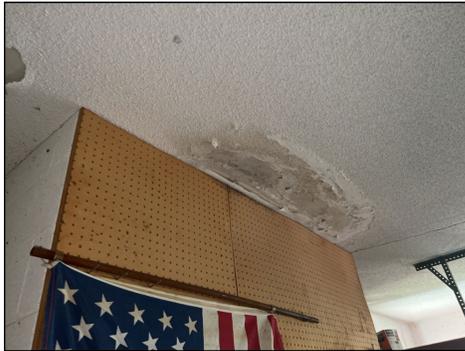
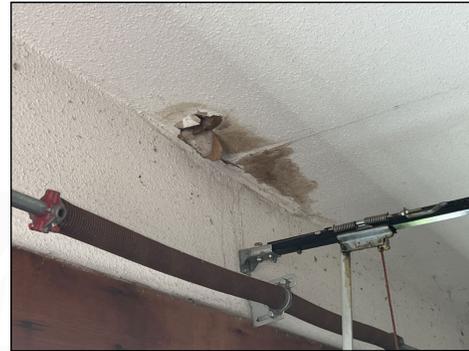
- The garage interior has finished surfaces that does not allow for evaluation of wall and ceiling framing.
- Stored items, furnishings, window treatments, decor, and personal items were present and limited inspection of non-visible areas.
- Stains on the ceiling were visible at the time of the inspection and may be the result of moisture intrusion from flashings and/or roof leaks located in or at the above area(s). Hidden conditions were not evaluated and may contain concealed damage or microbial growth. There is no indication of current leaking. Ask the seller about this condition and/or have a qualified contractor further examine to determine the source of the water stains, making repairs and repainting affected finished surfaces as necessary.
